**CLIFTON PARK WATER AUTHORITY
BOARD MEETING**

Re: Clifton Park Water Authority – Tank Inspection Report Summary and Recommendations

Subject: Knoll Top Tank Sprint Removal Inspection Report

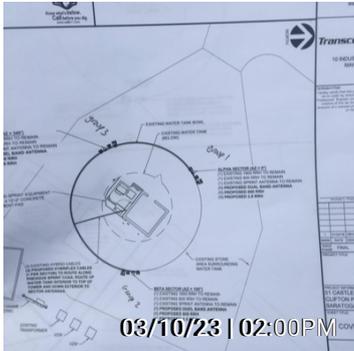
1. Water tower grouping

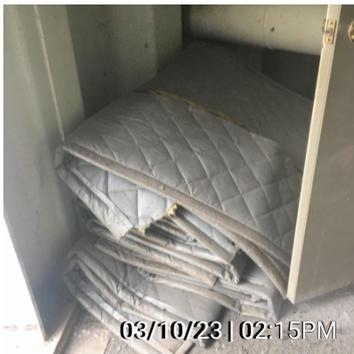
1. Blanket materials were left behind. See Note 2 of the attached report.
2. The grounding wire that served the Sprint equipment was left in place. See Note 3 of the attached report.
3. Miscellaneous support brackets that supported Sprint equipment were left in place. See Note 4 of the attached report.
4. Conduit penetration and junction box covers which served Sprint equipment were not sealed. See Note 5 of the attached report.
5. Holes in the tank exterior cladding were not sealed. See Note 6 of the attached report.
6. The antenna mounts on the tank were left in place. See Note 8 of the attached report.
7. The paint utilized to for the areas impacted by the equipment removal does not match the color of the existing tank. The existing tank paint is Tnemec Fascinate 02GN. See Note 9 of the attached report.

2. Items left behind from sprint

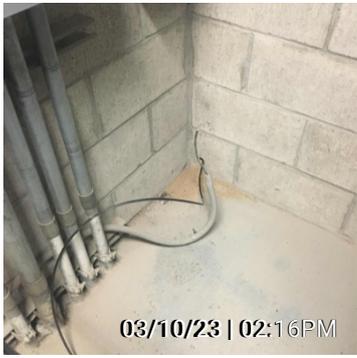
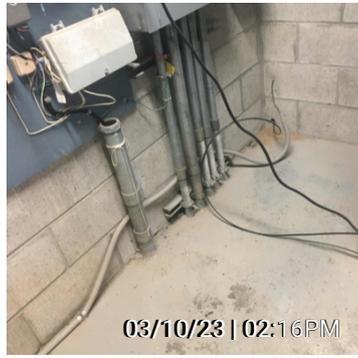
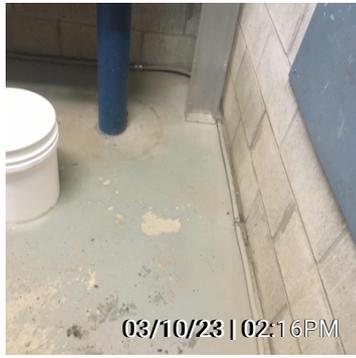
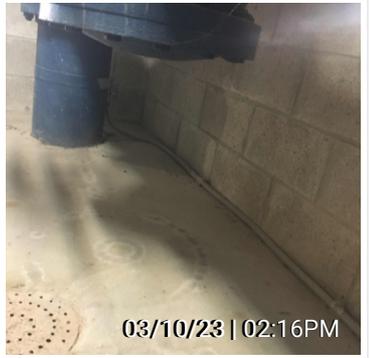
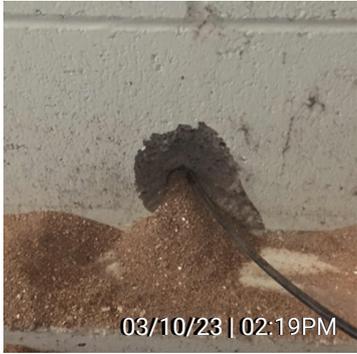
3. Grounding wire just cut and left

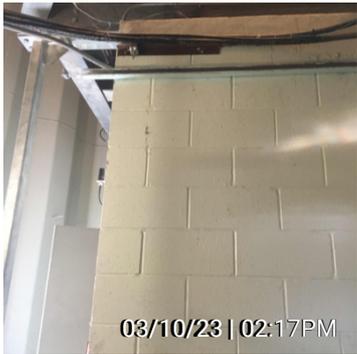
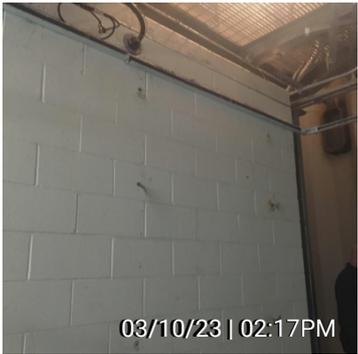
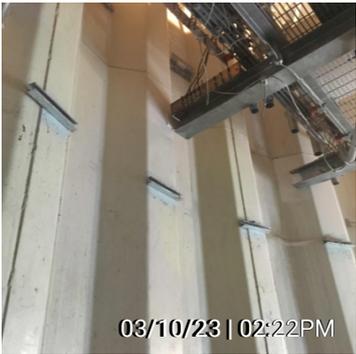
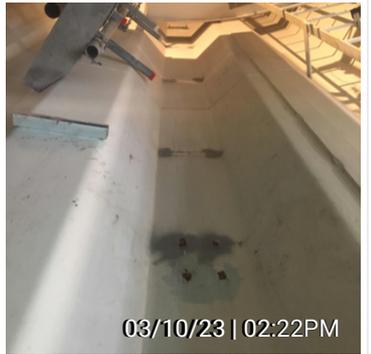
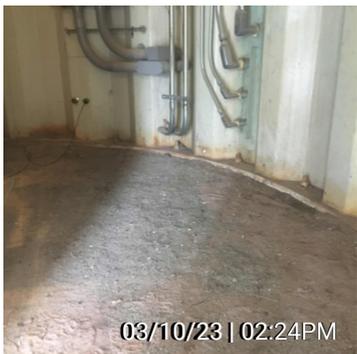
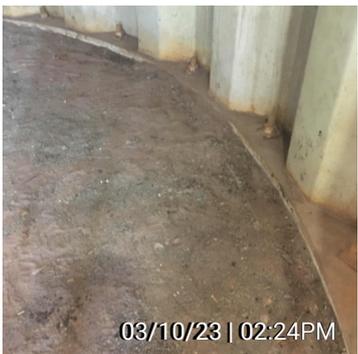
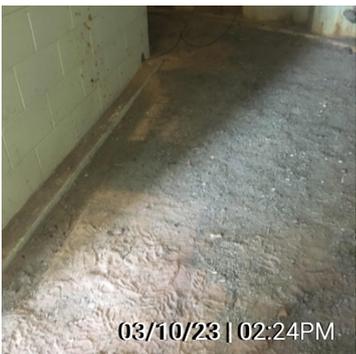
4. Wall/area that use to hold sprints equipment. Brackets left behind

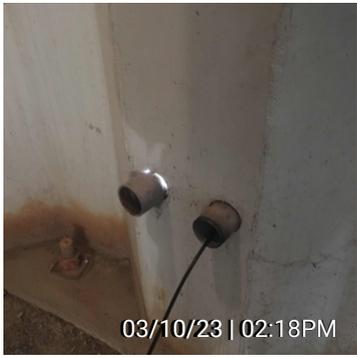
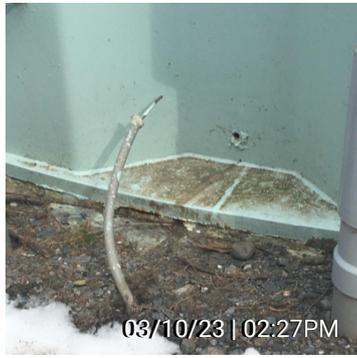
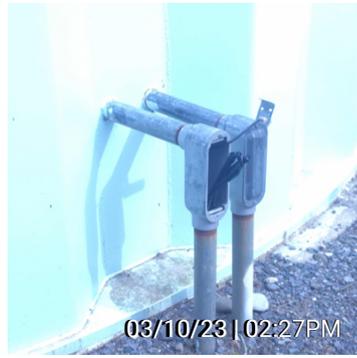
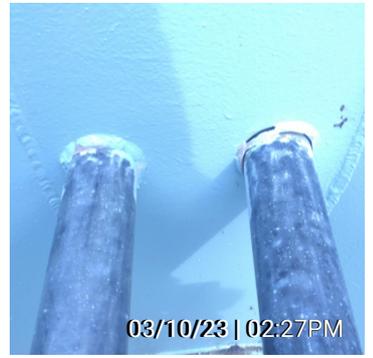
5. Pipe penetrations from sprint left. Lines just cut and left along with conduit.

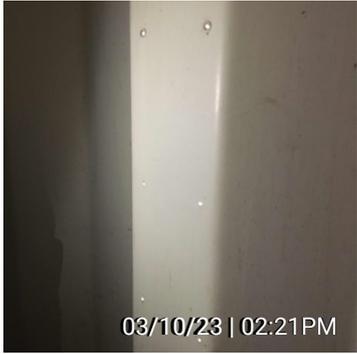
6. Unknown drill holes.

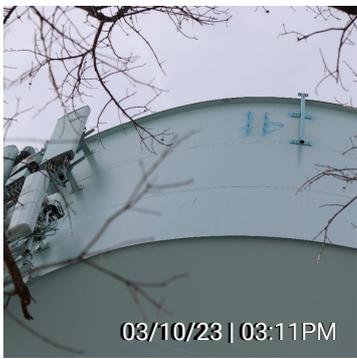
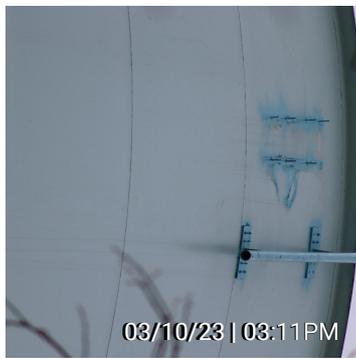
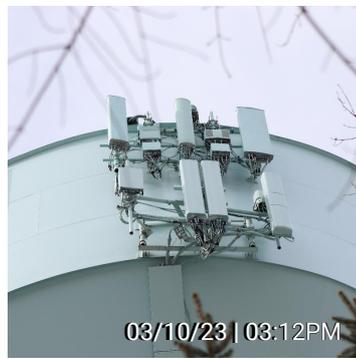
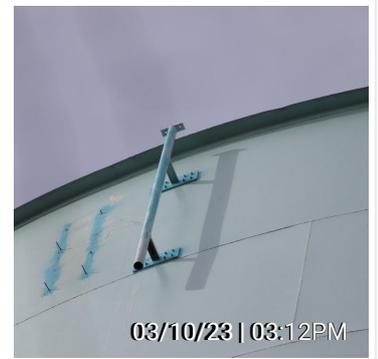
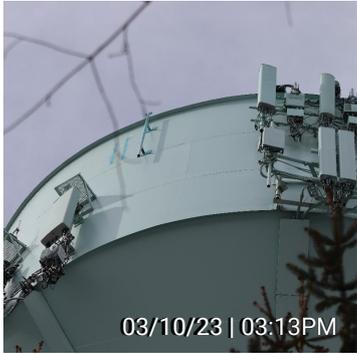
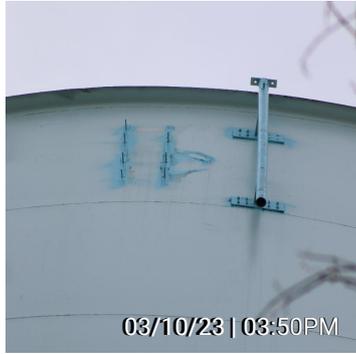
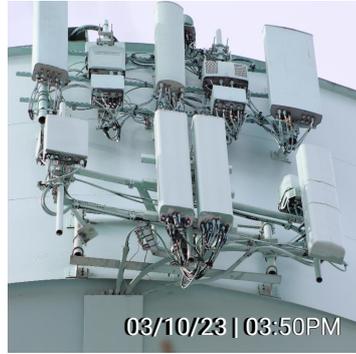
8. Cell group 2 - Sprint major equipment removed except the antenna mounts. Paint color doesn't match

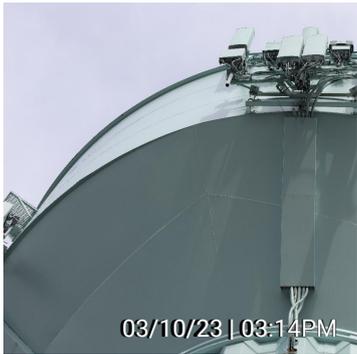
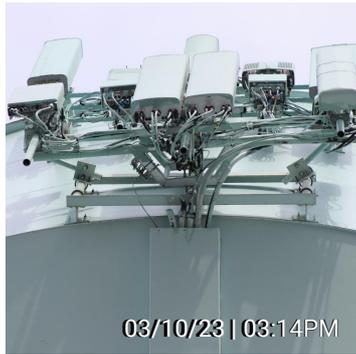
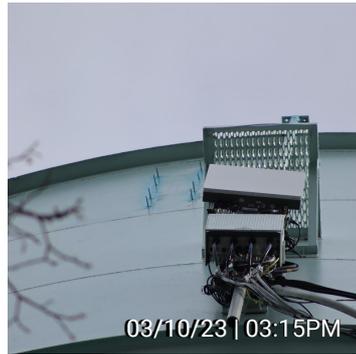
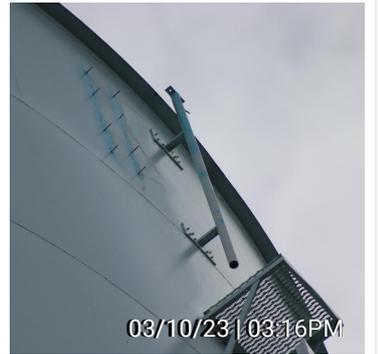
9. Cell group 3 - Spectrum major equipment removed except the antenna mount. Paint color doesn't match
