**CLIFTON PARK WATER AUTHORITY
BOARD MEETING**

Ground-Water Resources of the Clifton Park Area, Saratoga County, New York

Smith Well Drilling is providing this report and related recommendations in accordance with the recent cleaning and redevelopment of the Berryfarm 12" well. The work was performed between July 2 and July 15th, 2010. Work was postponed from the scheduled week of July 5 – July 12, 2010 due to high heat and excessive water consumption at the request of the Clifton Park Water Authority, so as to minimize any impact by having this well out of service during this higher than average peak demand period.

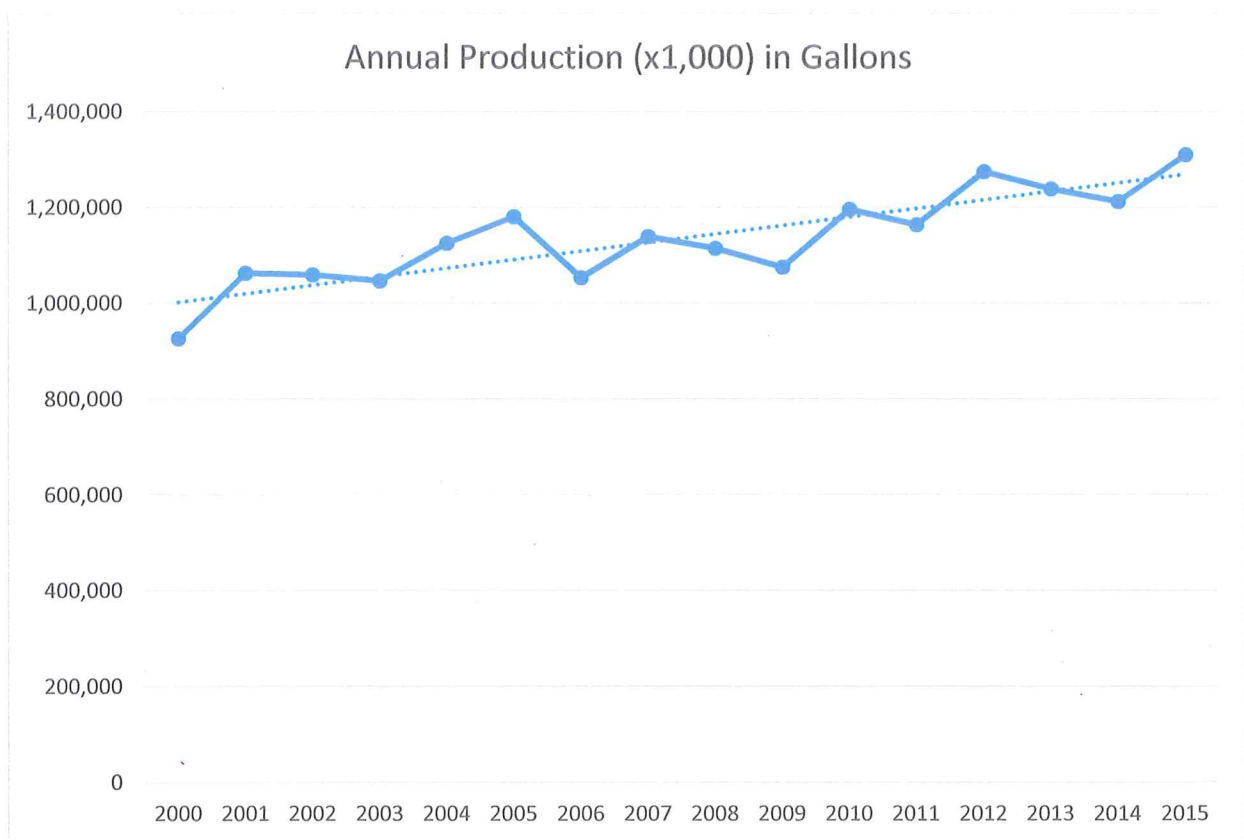
Annual production numbers have steadily increased from 2000 to 2015, from 925,700,000 gallons in 2000 to 1,309,755,000 in 2015, an annual average increase of 25,604,000. While annual production increases don't necessarily show a need to increase pumping capabilities, as increases in peak day values would, they create a greater draw on seasonal sources that may not be able to sustain additional pumping over the long haul. The effects of this can be seen in recent well reports accompanying this analysis, showing a decline in the pumping yields of wells within the Colonie Channel Aquifer.
